4.3. Hazard Profiles and Vulnerability Analysis

4.3.1. Coastal Erosion

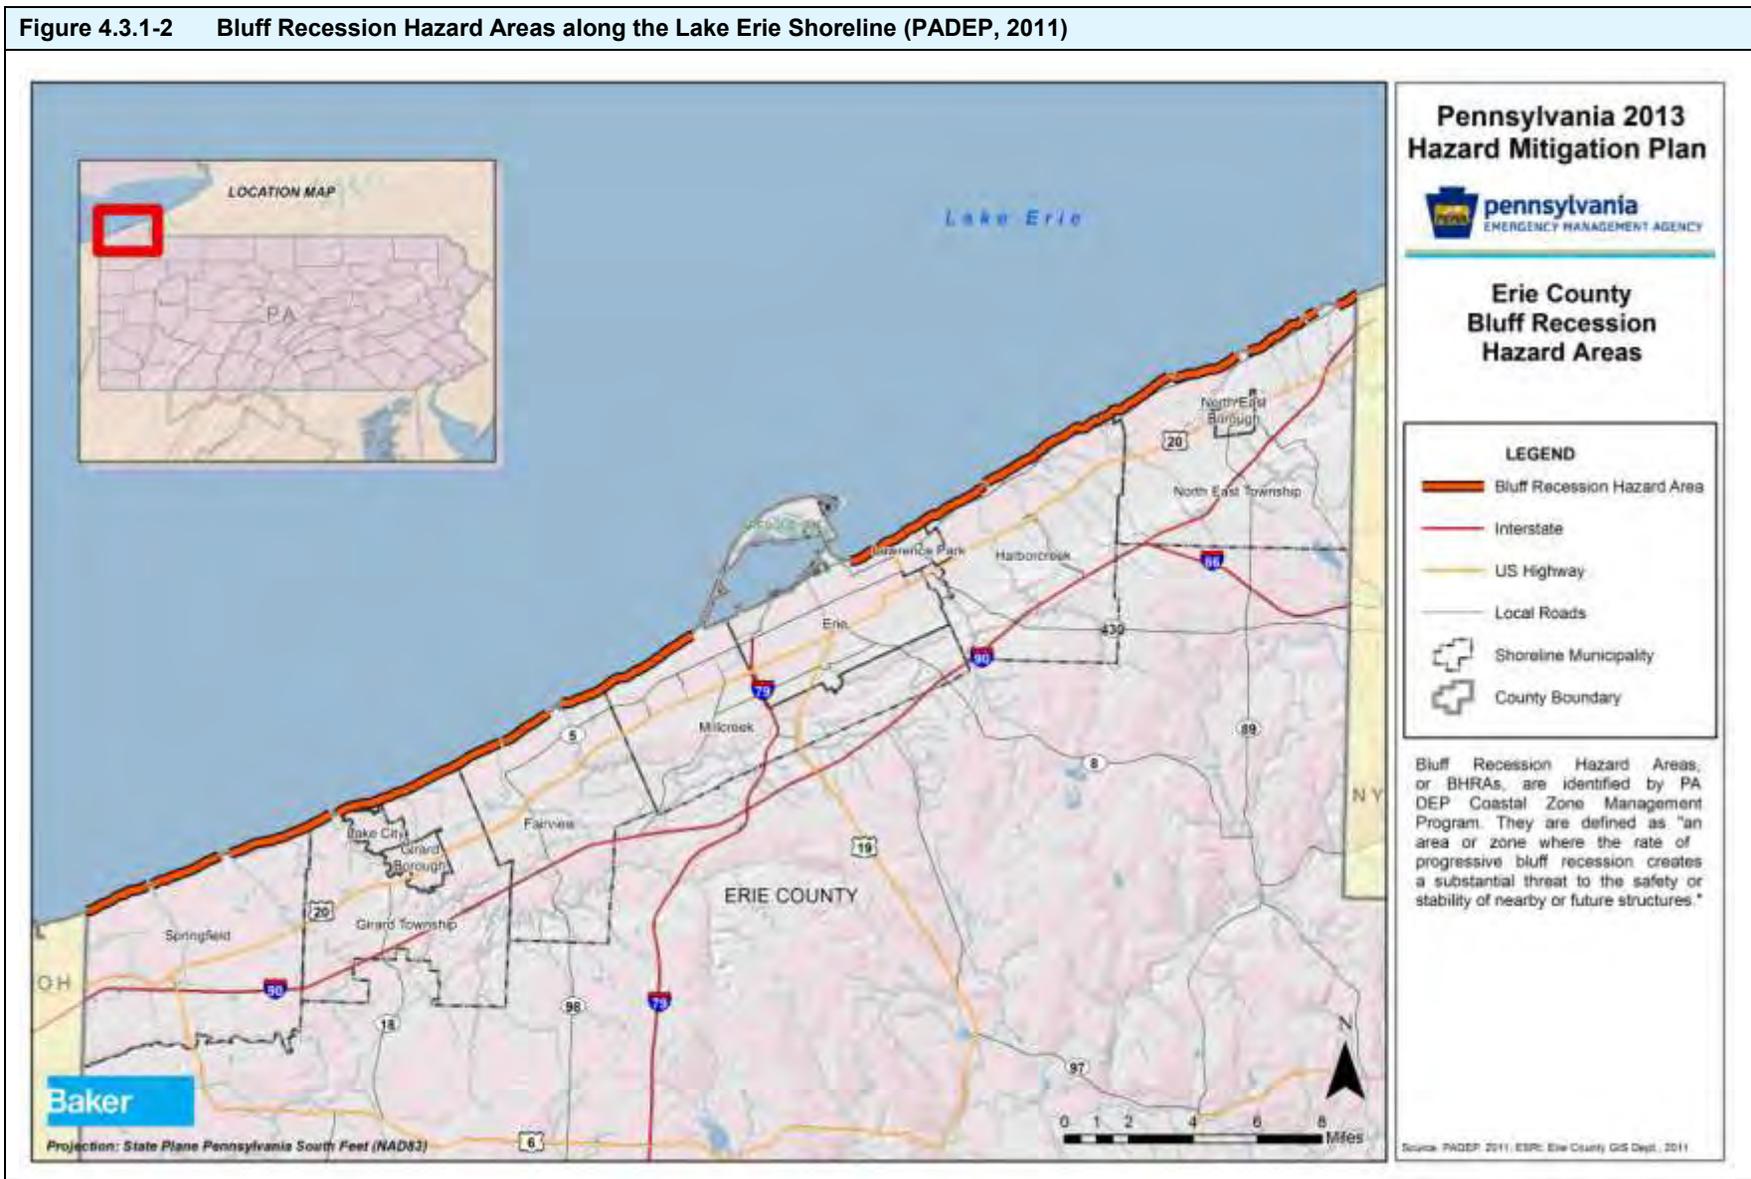
Figure 4.3.1-2 Bluff Recession Hazard Areas along the Lake Erie Shoreline (PADEP, 2011)

Figure 4.3.1-2 identifies Bluff Recession Hazard Areas (BRHAs) identified by the Pennsylvania Department of Environmental Protection Coastal Zone Management Program. BRHAs are defined in Section 3 of the Bluff Recession and Setback Act as “an area or zone where the rate of progressive bluff recession creates a substantial threat to the safety or stability of nearby or future structures or utility facilities.” These bluffs are present along the majority of Erie County’s border with Lake Erie and present a hazard. Original designations of BRHAs, codified at 25 Pa. Code § 85.26, are based on a 1975 study titled *Shoreline Erosion and Flooding – Erie County* (PADEP, 2004). Current designations were established in 2009 based on a 2004 study titled, *Study to Tentatively Designate Bluff Recession Hazard Areas*. All BHRAs were first established in 1980 except for the BRHA within the City of Erie, which was established during the 2009 update (PADEP, 2011).

The BRHAs determine where along the shoreline development will be subject to Minimum Bluff Setback Distances. Sections of shoreline which are not identified as a BRHA (e.g. beach and dune areas, headlands, armored shorelines, etc...) may not be subject to bluff recession, but remain vulnerable to shoreline erosion.

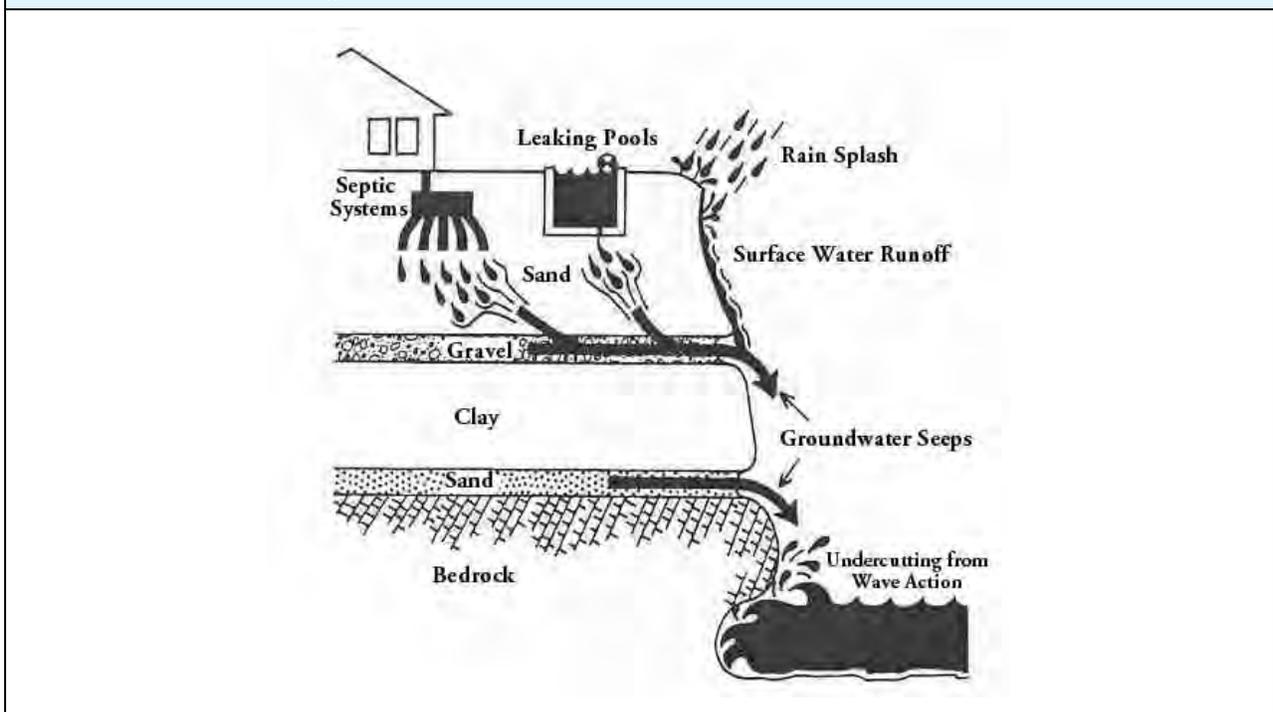
Figure 4.3.1-3 Diagram showing many of the natural and human-induced processes which influence result in coastal erosion along the Lake Erie shoreline.

Bluff recession and shoreline erosion events can take place gradually over decades or abruptly during a single storm event. The magnitude of bluff recession and shoreline erosion events depends greatly on fluctuating lake levels and the amount of beach material along the shoreline, but other factors that affect rate of change include surrounding land use, storm impacts, vegetative cover, soil type, depth of unconsolidated soils, hydrology, bedrock geology, slope gradient, offshore bathymetry and human activity. Figure 4.3.1-3 illustrates both the natural and human-induced processes which influence bluff recession rates of change.

Bluff instability often occurs as a result of erosion of foreshore beach materials and the undercutting of bluffs by wave attack. However, slumping and mass-wasting of the bluff face can also occur without the presence of direct wave attack. Erosion of the bluffs may be accelerated by groundwater seepage, surface water runoff, and human activity or changes in land use that would alter the hydrology or vegetation on a site.

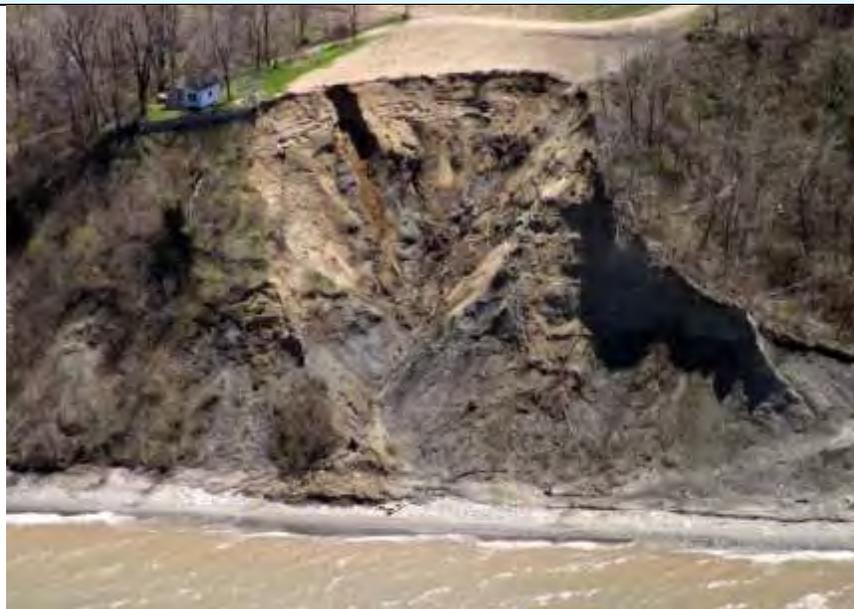
Figure 4.3.1-4 Photograph of large avulsive event along the Lake Erie, PA shoreline (USGS, 2009 and the Pennsylvania Coastal Resource Management Program.

The impacts of bluff recession and shoreline erosion may be minimal in areas where buildings and infrastructure have been constructed at an adequate setback distance or erosion mitigation measures have been employed. However, development within and south of designated hazard areas can result in damage or complete destruction of property and public infrastructure as well as threats public health and safety. A worst-case scenario for coastal erosion would be if coastal erosion from a strong storm occurred, causing a slumping or mass-wasting of a bluff and numerous homes on the bluff to collapse. This could result in not only property damage, but loss of life or injuries if the homes are occupied at the time of the slope collapse. Figure 4.3.1-4 shows an example of a building imminently threatened by significant bluff recession, dating back to the 1970s. Figure 4.3.1-5 shows an example of a collapsed retaining structure.

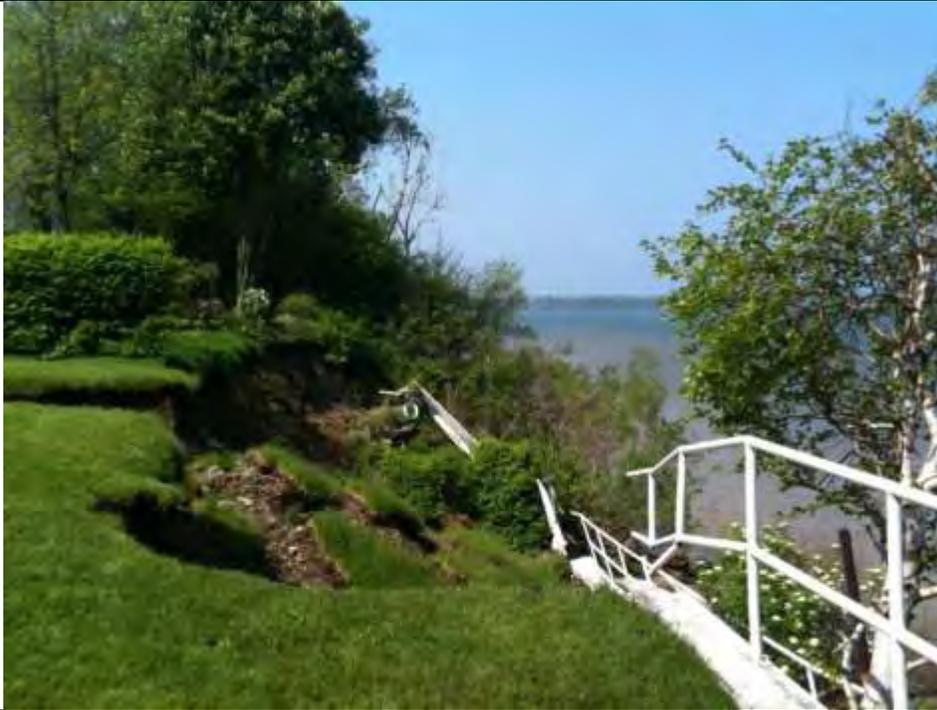
Figure 4.3.1-5 Photograph of collapsed retaining wall structure along the Lake Erie, PA shoreline (PADEP, 2011).

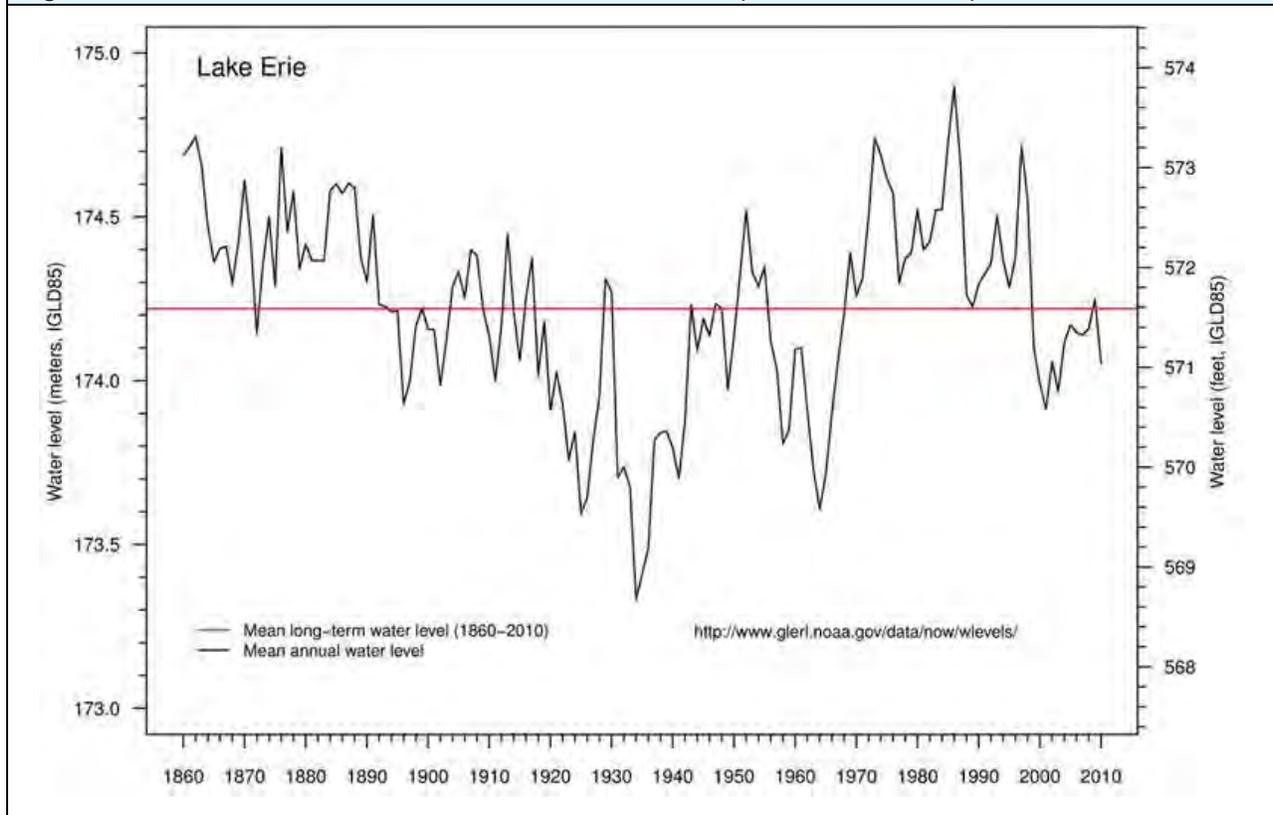
Figure 4.3.1-6 Lake Erie water levels between 1860 and 2009 (NOAA GLERL, 2011).

Lake levels significantly influence erosion and bluff recession rates. Periods of rising lake levels resulted in increased erosion rates. Glacial isostatic rebound may still be a small factor in changing lake levels, but most modern lake-level changes are attributable to climatic factors. Long-term changes are caused by variations in precipitation and evapo-transpiration rates. Figure 4.3.1-6 shows average annual lake levels for the period 1860-2010. Lake levels have varied on the order of five feet over this time period. The droughts of the 1930's and 1960's are clearly reflected in the lake levels. Between 1987 and 1989, the lake level dropped to near its long-term average. An annual cycle and short-term changes related to weather also affect the lake level.

The most severe erosion events occur when lake levels are at their highest. This is reflected in the fact that 1987 and 1998 erosion events referenced in Section 4.3.1.3 correspond with lake level peaks shown in Figure 4.3.1-6. The worst-case scenario for an erosion event would be an abrupt increase in lake levels of up to one meter lasting for several years in succession.

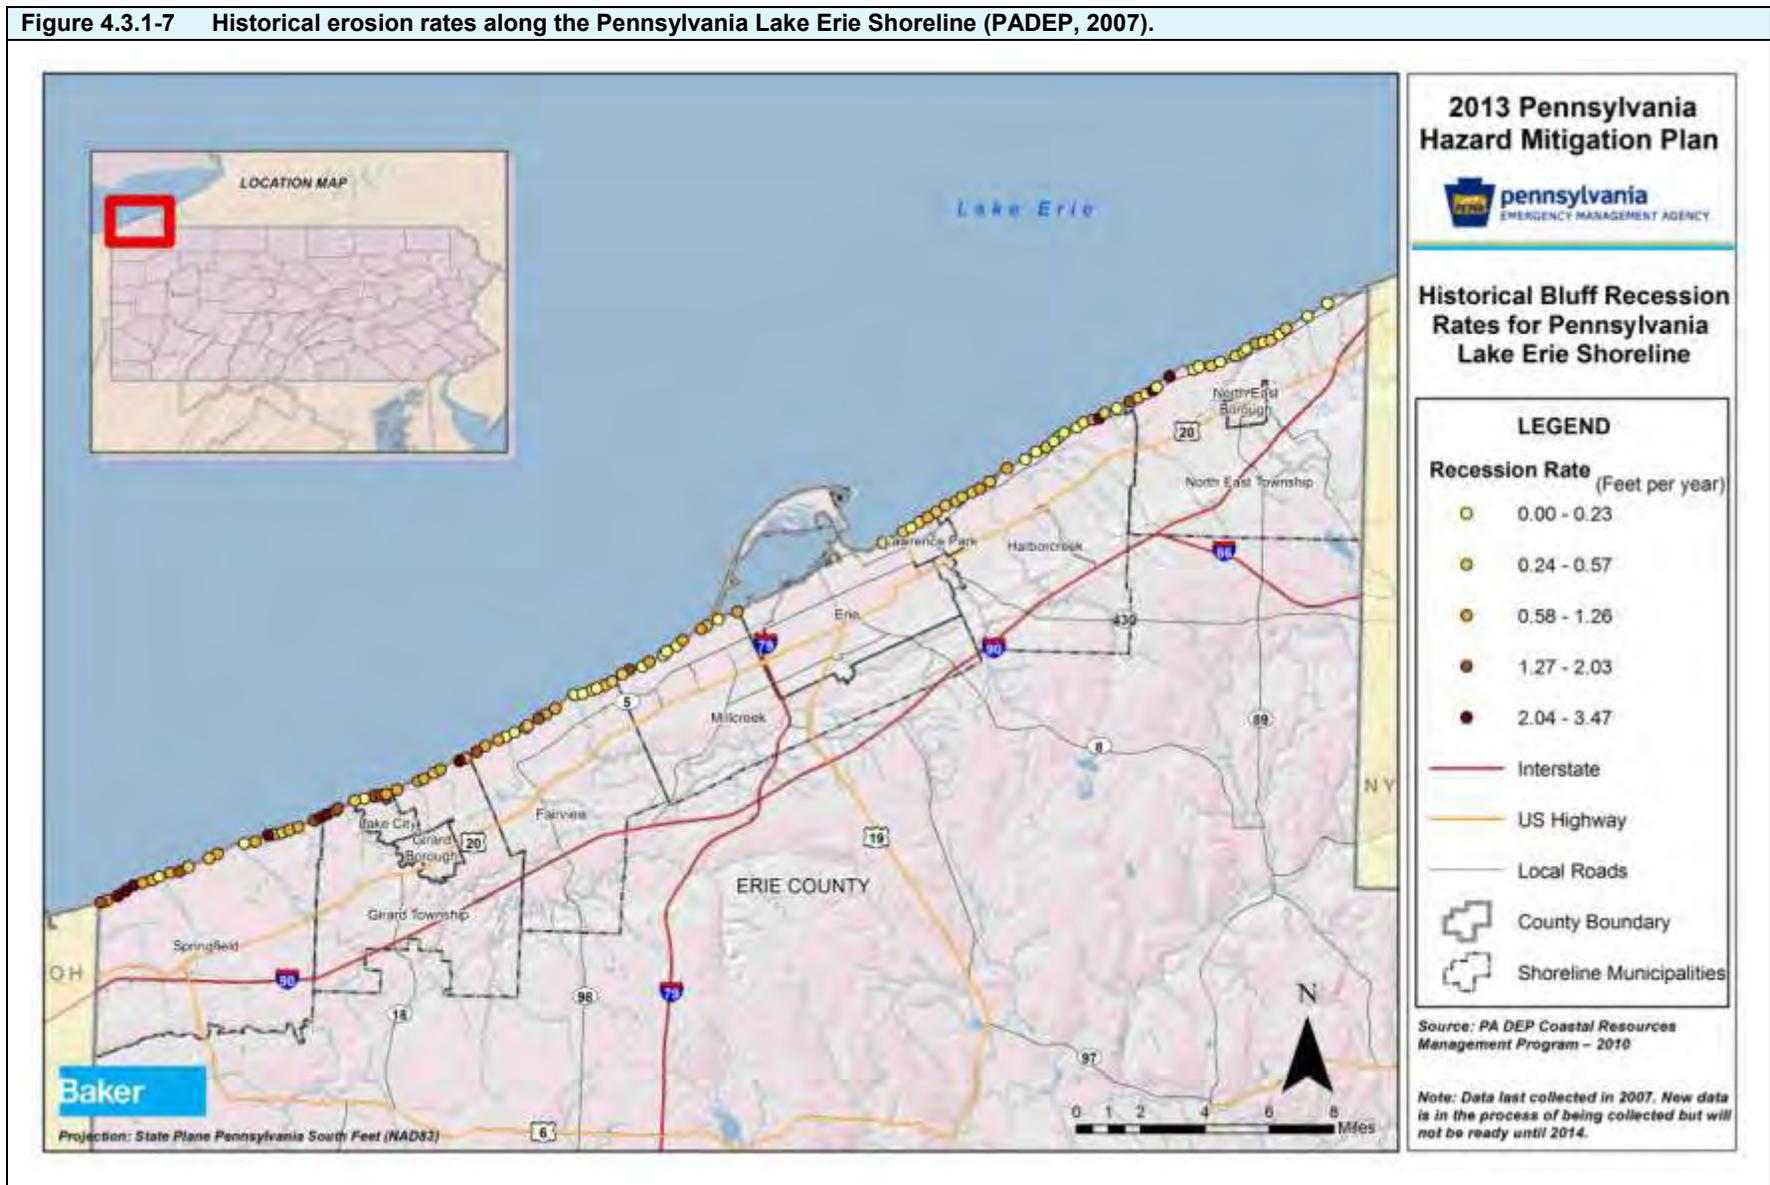
Figure 4.3.1-7 Historical erosion rates along the Pennsylvania Lake Erie Shoreline (PADEP, 2007).

The long-term average recession rate based on 125 fix control point monuments for the Pennsylvania Lake Erie Coastal Zone is 0.75 ft/yr; however, during the past two decades of monitoring, losses of up to twenty feet in a single year have been observed (Hapke et al., 2009 and Pennsylvania Sea Grant, 2002). Figure 4.3.1-4 displays historical bluff recession rates along the Pennsylvania Lake Erie shoreline. Erosion and recession rates are spatially variable and temporally episodic. This is evident by the fact that very low retreat rates have been measured at certain control points, while rates in immediately adjacent areas are much higher. A study performed by the U.S. Geological Survey in cooperation with the Pennsylvania Coastal Resources management Program divided the Pennsylvania Lake Erie shoreline into two areas along which recession rates were calculated (Hapke et al., 2009). Using data from 1938-2006, the study area extending southwest of Presque Isle had an average rate of recession of 0.98 +/- 0.33 ft/yr. Using data from 1938-1998, the study area extending northeast of Presque Isle had an average rate of recession of 0.66 +/- 0.33 ft/yr. A maximum rate of 3.28 +/- 0.33 ft/yr was measured in each study area, both occurring in predominantly agricultural areas.

The long-term average historical recession rate based on 130 fixed control point monuments for the Pennsylvania Lake Erie Coastal Zone is 1.0 ft/yr. Figure 4.3.1-6 displays historical long-term bluff recession rates along the Pennsylvania Lake Erie shoreline as of 2007. Field surveys are being performed through 2011 to update the control point monument data; this data is expected to be ready for release in 2014.
